RE: **Baruch College - Site "B"**
Contract #16 - GC #2
Epoxy Terrazzo - Uplift/Debonding

PRELIMINARY SITE INVESTIGATION REPORT

Client:	TDX Construction Corp.	Lab #:	Pending
Project:	Baruch College - Site B	Report #:	ML-01
Address:	55 Lexington Avenue	Field Visit Date:	03/04/03
	New York, New York	Report Date:	03/05/03
Construction Type:	Terrazzo flooring system on concrete slab	Petrographer:	J. Walsh
		Page 1 of 10

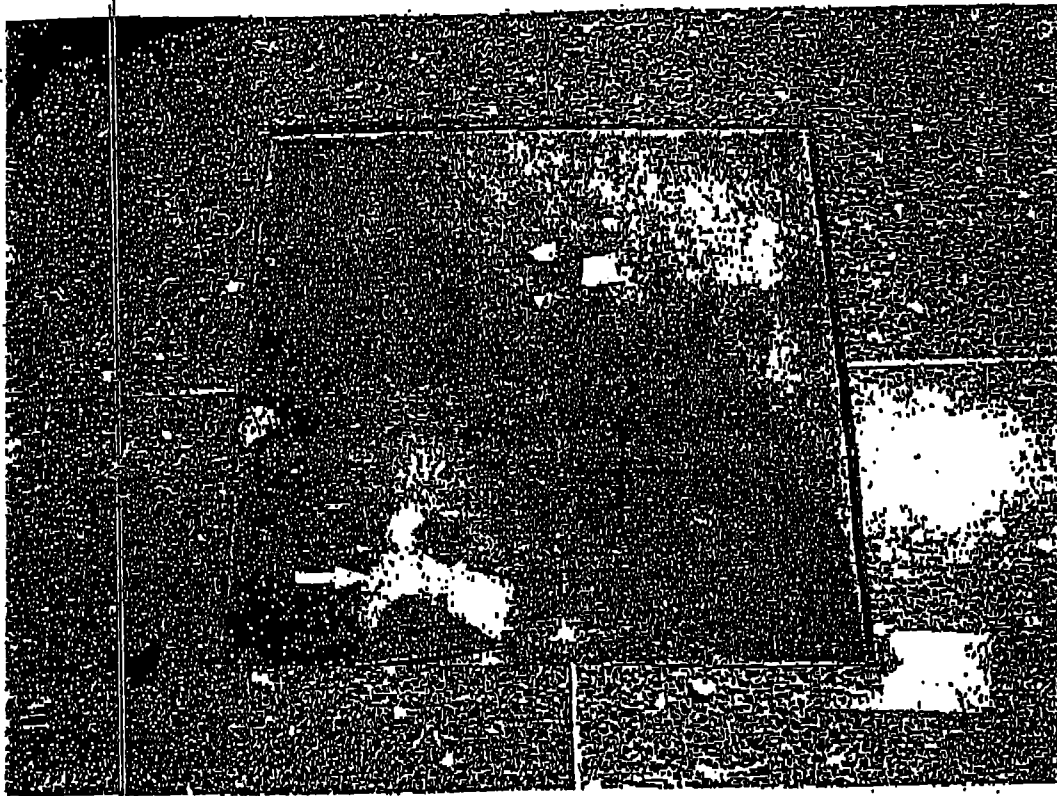
Figure 5: Probe location B1. The epoxy membrane is completely debonded from the smooth self-leveling compound surface. In the lower left quadrant (arrow), the self-leveling compound is clearly debonded from the concrete substrate. Sounding indicates that the debonding is present nearly everywhere below that one corner.
